Minerals Inspection Report

Mine Name: Bromide Basin	Permit Number: S/017/0031	Mine Status: Active
Operator Name: Bromide Mining LLC.	Inspection Date: 08/04/2015	Permit Fees: Paid
Inspector(s): Wayne Western	Inspection Time: 11:15 - 12:15 pm	Bond Amount: \$57,600
Attendee(s): John Reay	Weather: warm and sunny	Bond Escalation: 07/22/2017
Inspection Purpose: Routine inspection		Prior Inspection: 07/09/2014

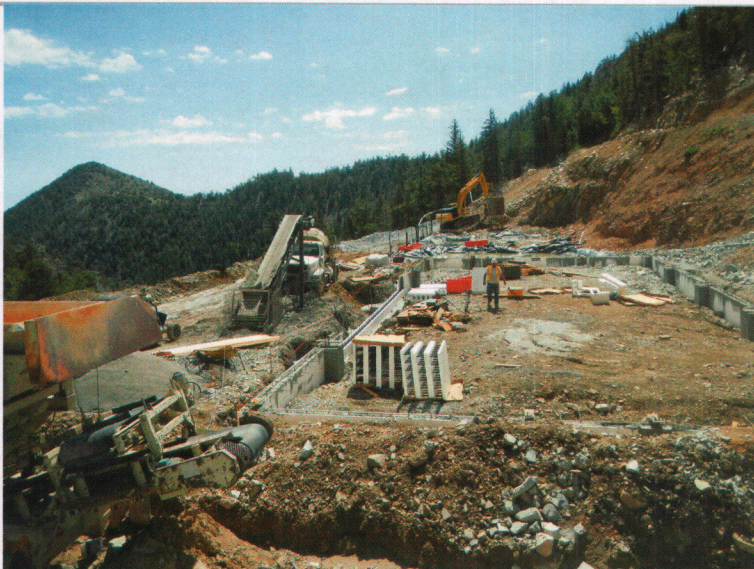
Construction of Har El Mill looking south, notice the foundation being constructed.

The Operator must update the NOI and bonds to reflect the on the ground conditions; specifically the bond must be increased to cover the demolition of the new buildings.

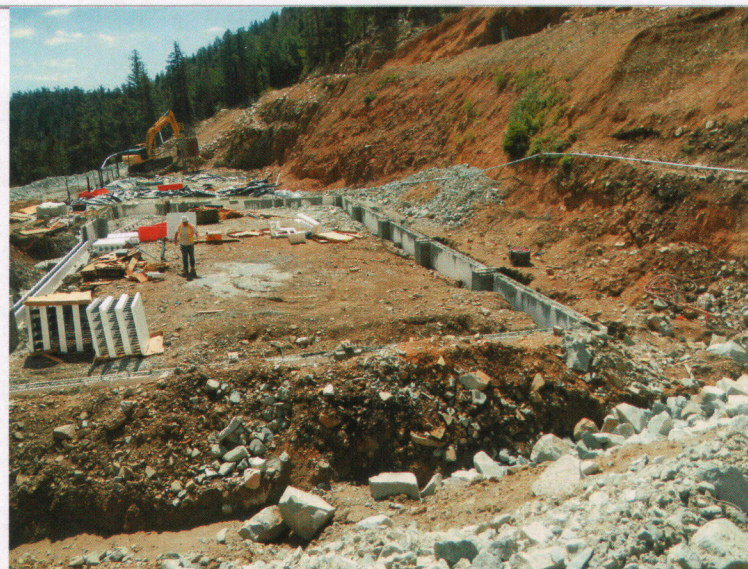
Construction of Har El Mill looking southwest, notice the foundation being constructed.

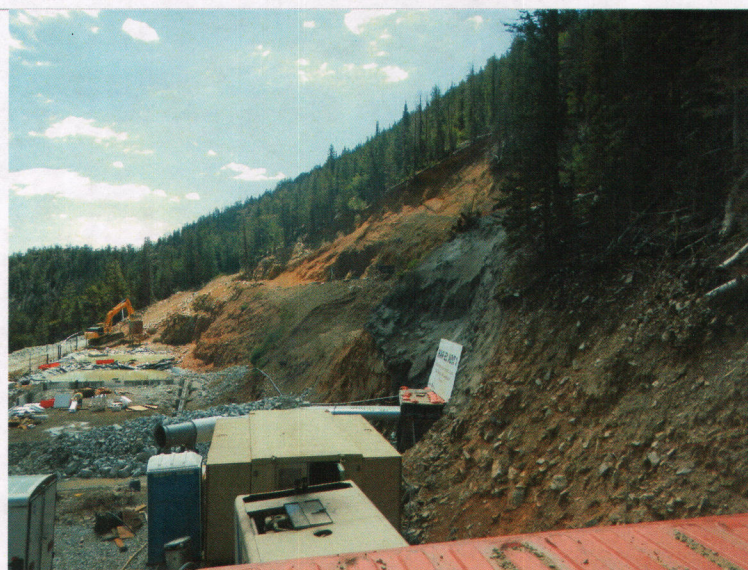
Construction of Har El Mill looking south, notice the foundation being constructed. Har El adit on right.

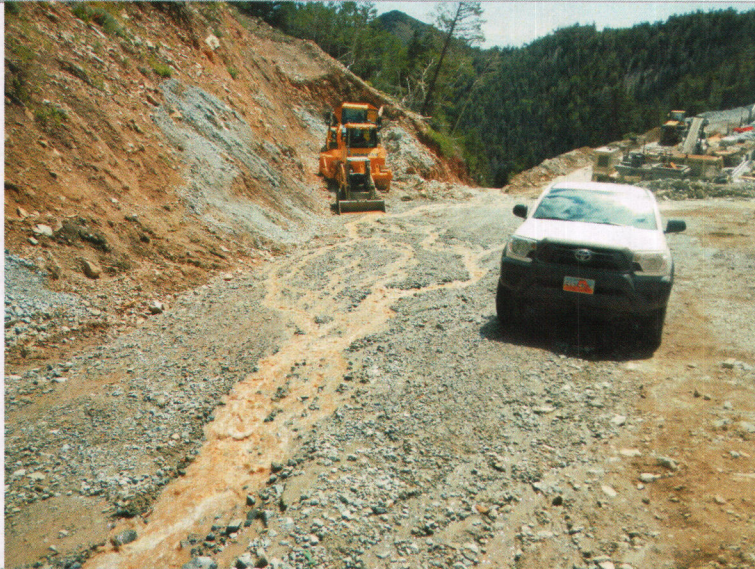
5. Roads (maintenance, surfacing, dust control, safety)	<input checked="" type="checkbox"/>	<input checked="" type="checkbox"/>
The roads to not have ditches on the sides water from a pond was being discharged onto the roads.

Looking north, water from pond following down road.

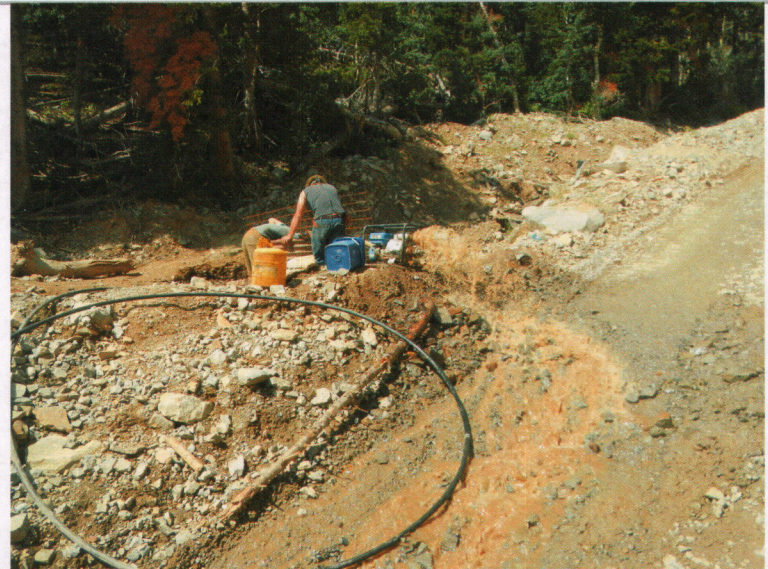
Culvert and pond plugged, water being discharged onto road.

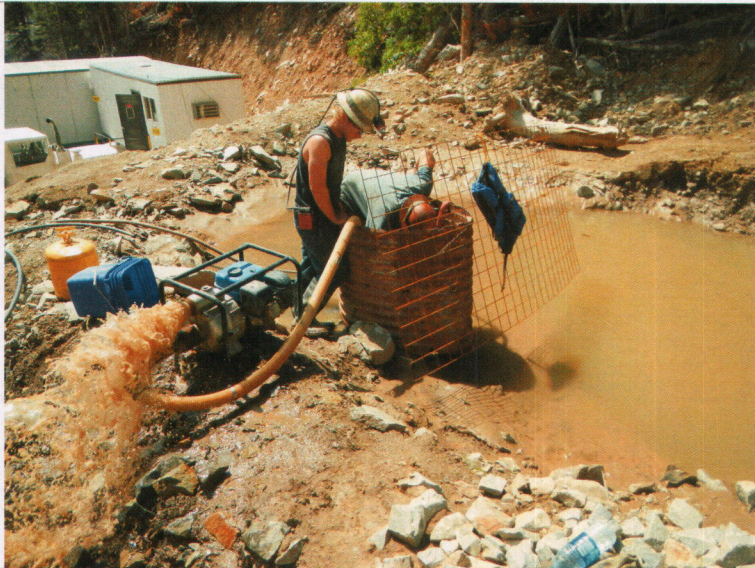
Workmen trying to unplug culvert. Discharging water from the pond onto road.

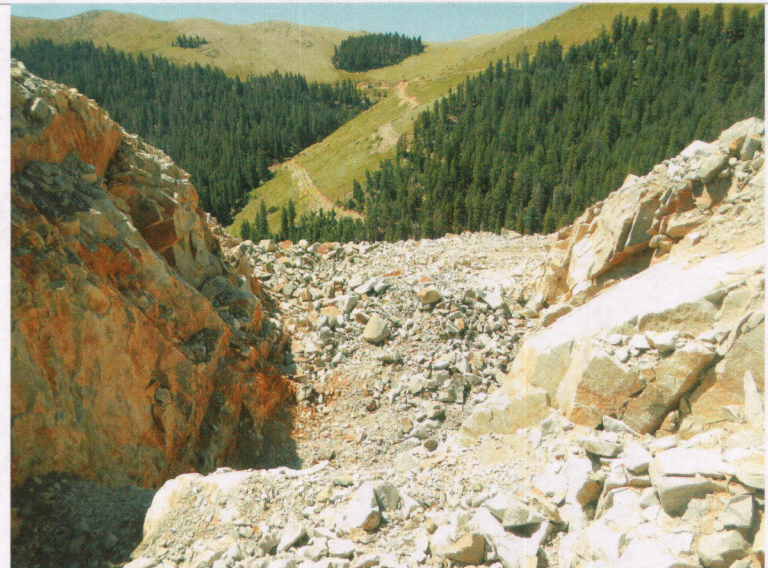
The Operator was mining the vein above the underground workings at the Bromide Mine and broke into the underground workings. The Operator sealed the breach with a steel plate and placed rocks on top of the plate. The reason for the temporary seal is to prevent unwanted ventilation in event of a fire (potential for outside air to feed the fire). The Operator needs to address how the opening will be permanently sealed.

Area above Bromide Mine working where Operator broke into underground workings. Opening covered with steel plate and plate covered with rock.

2. Public Safety (shafts, adits, trash, signs, highwalls)	<input checked="" type="checkbox"/>	<input type="checkbox"/>
The Operator was mining the vein above the underground workings at the Bromide mine. The Operator sealed the opening with a steel plat and covered it with rock. The Division will defer to MSHA for the safety of the temporary seal. For a permanent seal the Division would like a reinforced concrete slap.

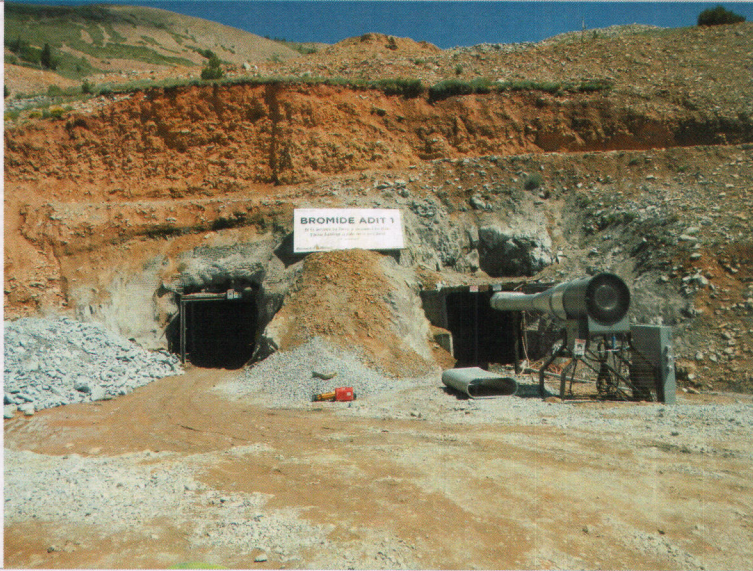
Two adits at Bromide Mine - only one shown on map

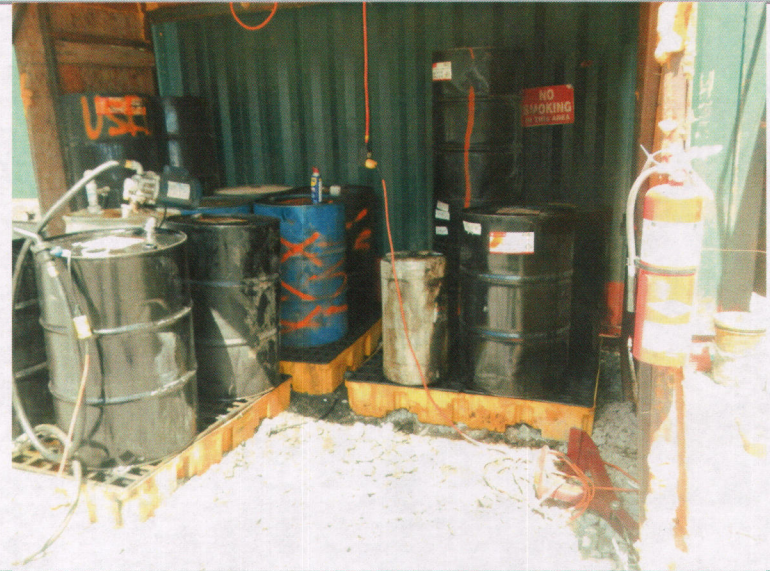
3. Protection of Drainages/Erosion Control	<input checked="" type="checkbox"/>	<input checked="" type="checkbox"/>
The sediment pond		
4. Deleterious Material	<input checked="" type="checkbox"/>	<input checked="" type="checkbox"/>
There was a warehouse/shop constructed near the Bromide adits. There were several oil drums place outside the building. Oil had spilled onto the rock underneath and next to the drums.

Oil spilled on the ground. Containers are not in a containment structure.

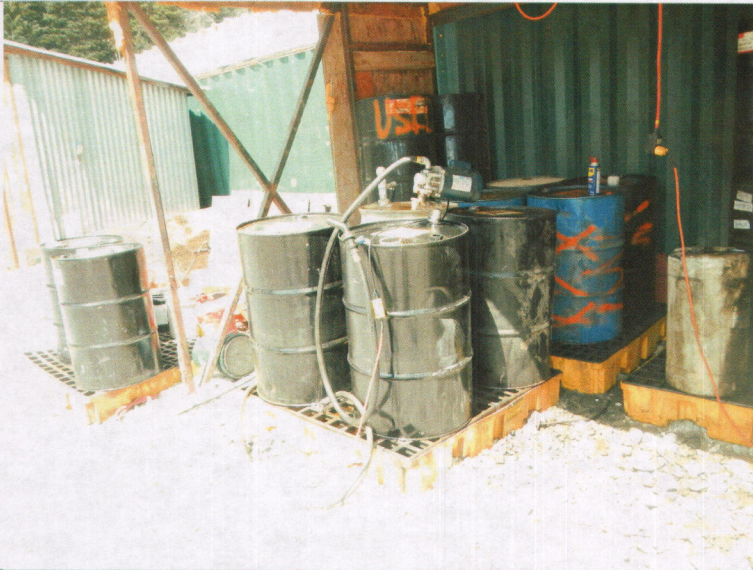
Containers are not in a containment structure.

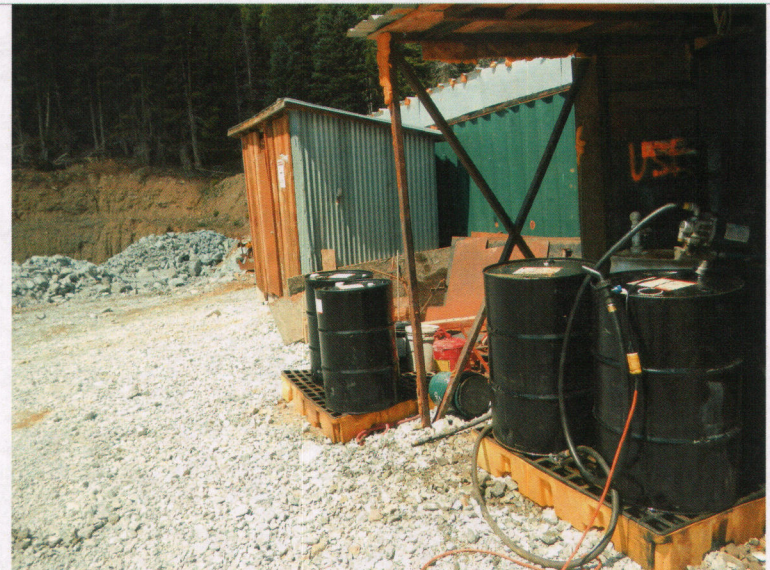
Containers are not in a containment structure.

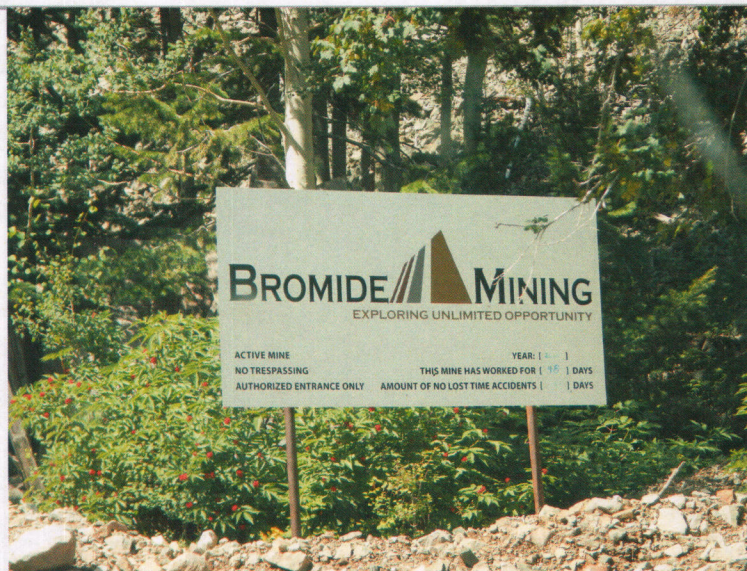
Entrance to Bromide Mine. The BLM is surveying the area to make sure gates are on private land.
